NBSIR 73-140

Fire Endurance Test of Plywood-Faced Exterior Walls for Single Family Housing

Final Report

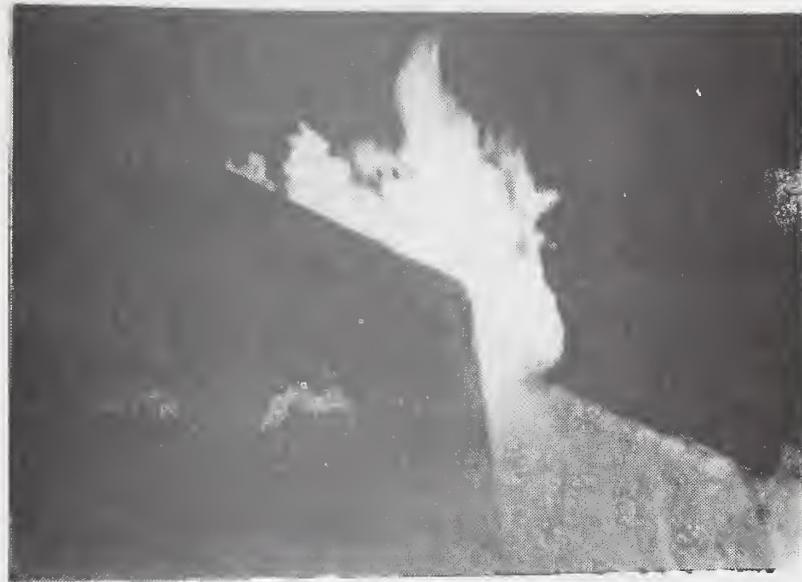
During the test when the flame penetration, shown in Figure 7, occurred at 47 min of test time, the gas supply to the burners was discontinued and thermocouples were disconnected; however, the combustion of the assembly continued. Figure 9 shows the complete burning of the single wall, while the double wall was still providing a barrier to flame penetration.

Figure. 7 Location of the flame through.

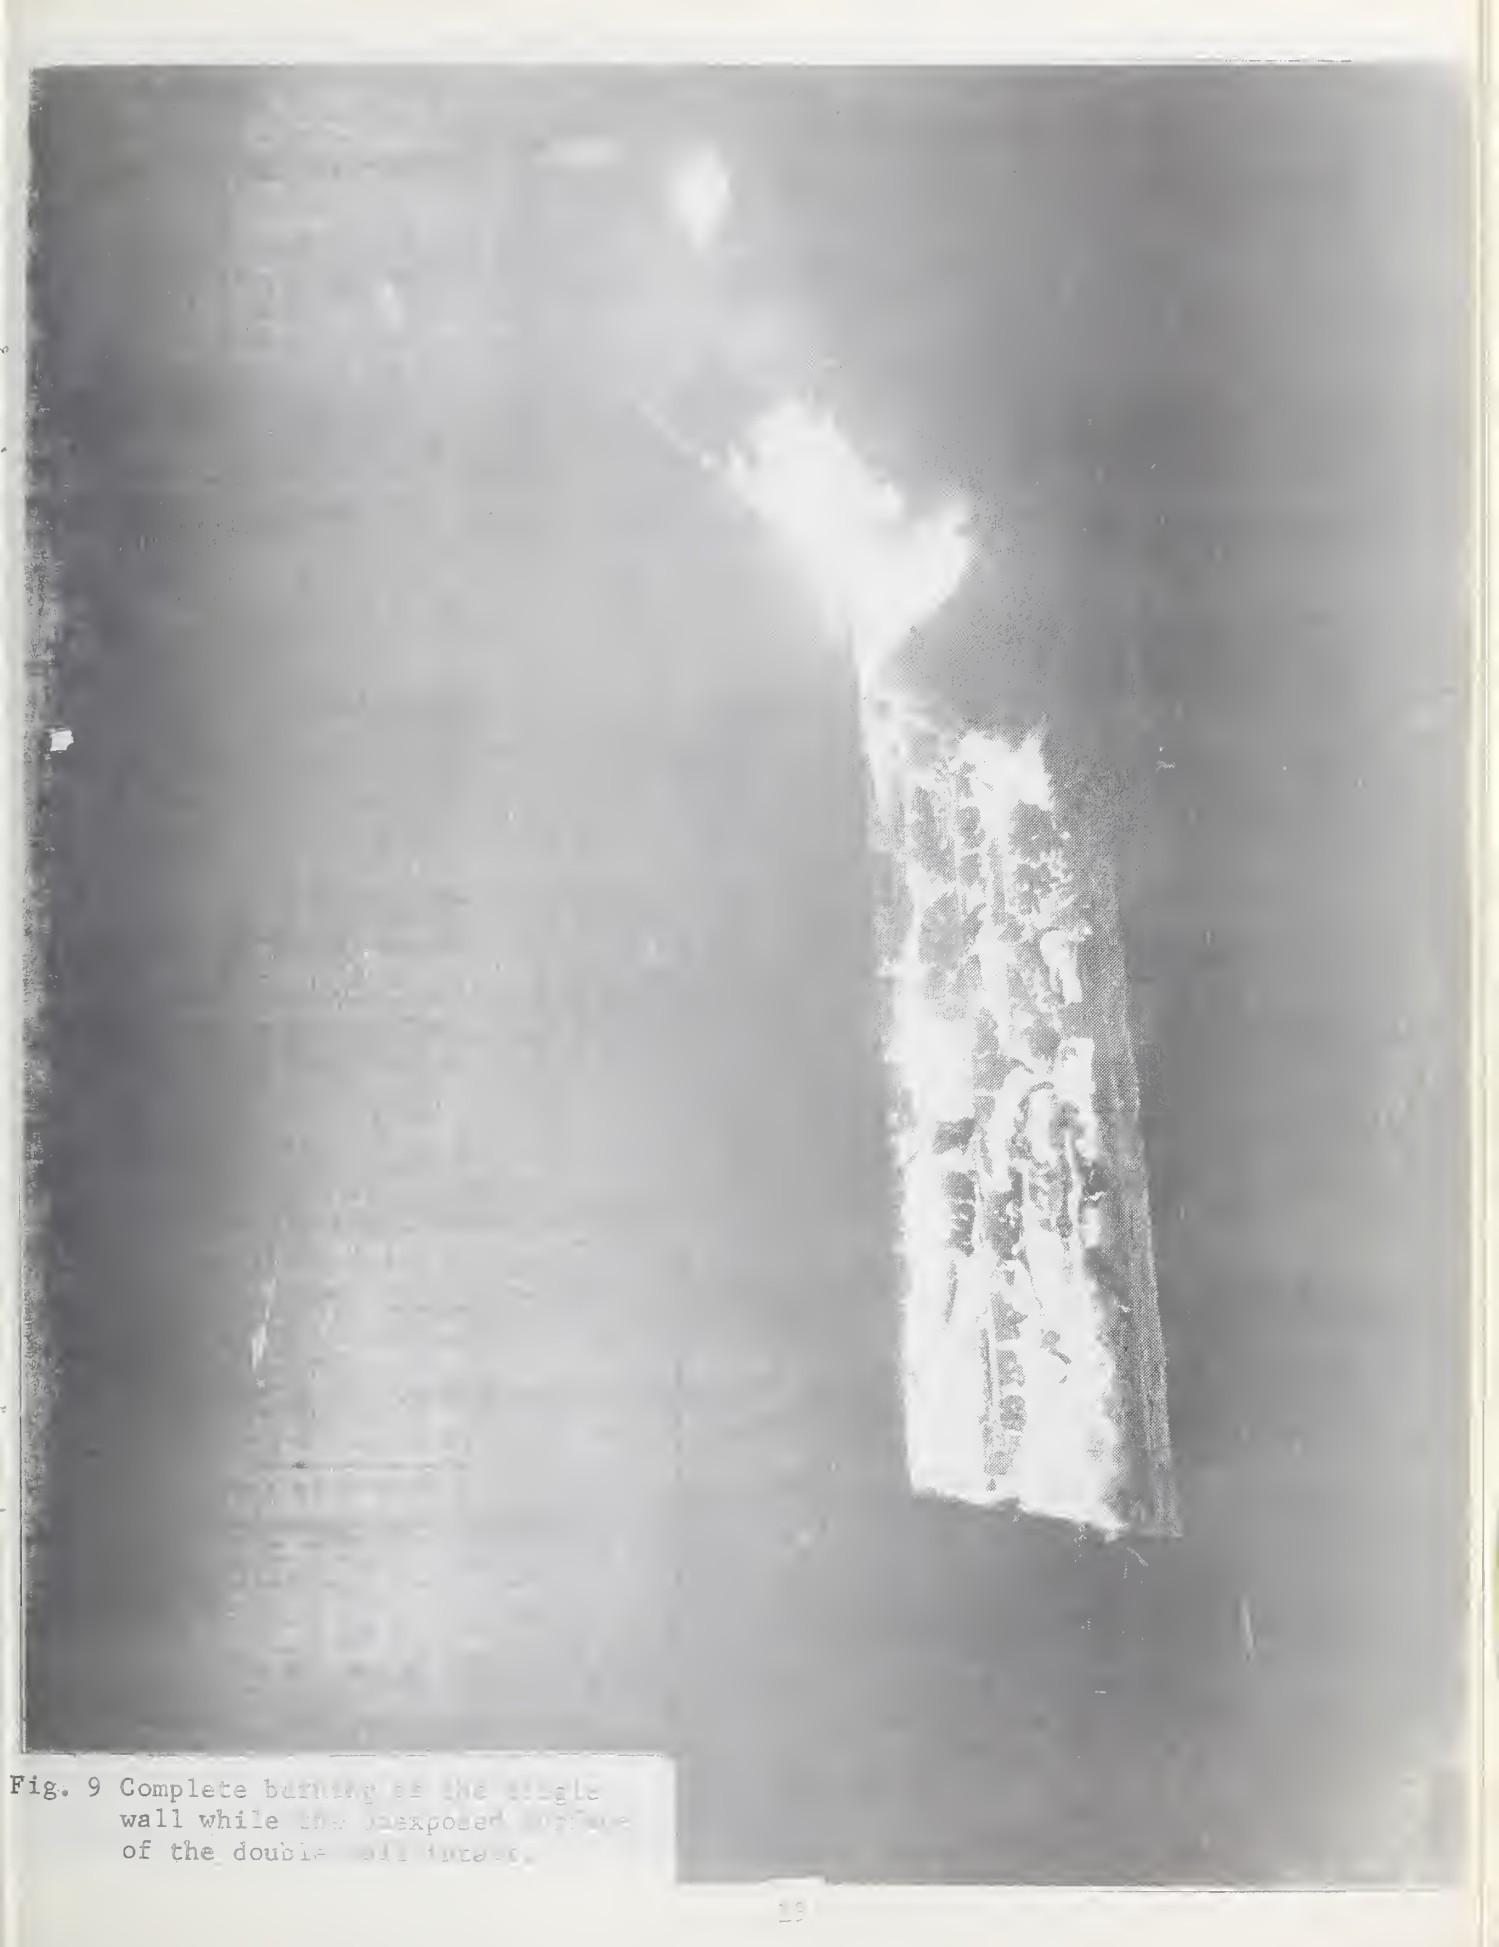
Figure 9, taken at 55 min of test time, shows burning of the single wall portion. Some flame and gray smoke are visible at top of the double wall portion. Flame penetration had taken place at the top of the double

wall portion, but had not yet penetrated to the unexposed surface of the double wall. The failure time of the double wall portion was estimated to be 1 hr 02 min when the unexposed gypsum board was losing contact with the wood studs. Figure 10, taken at approximately 1 hr 15 min of test time, shows the exposed side of the assembly after it was moved from the furnace while water was being applied from a fog nozzle.

Fig. 9 Complete burning of the single wall while the unexposed surface of the double wall intact.

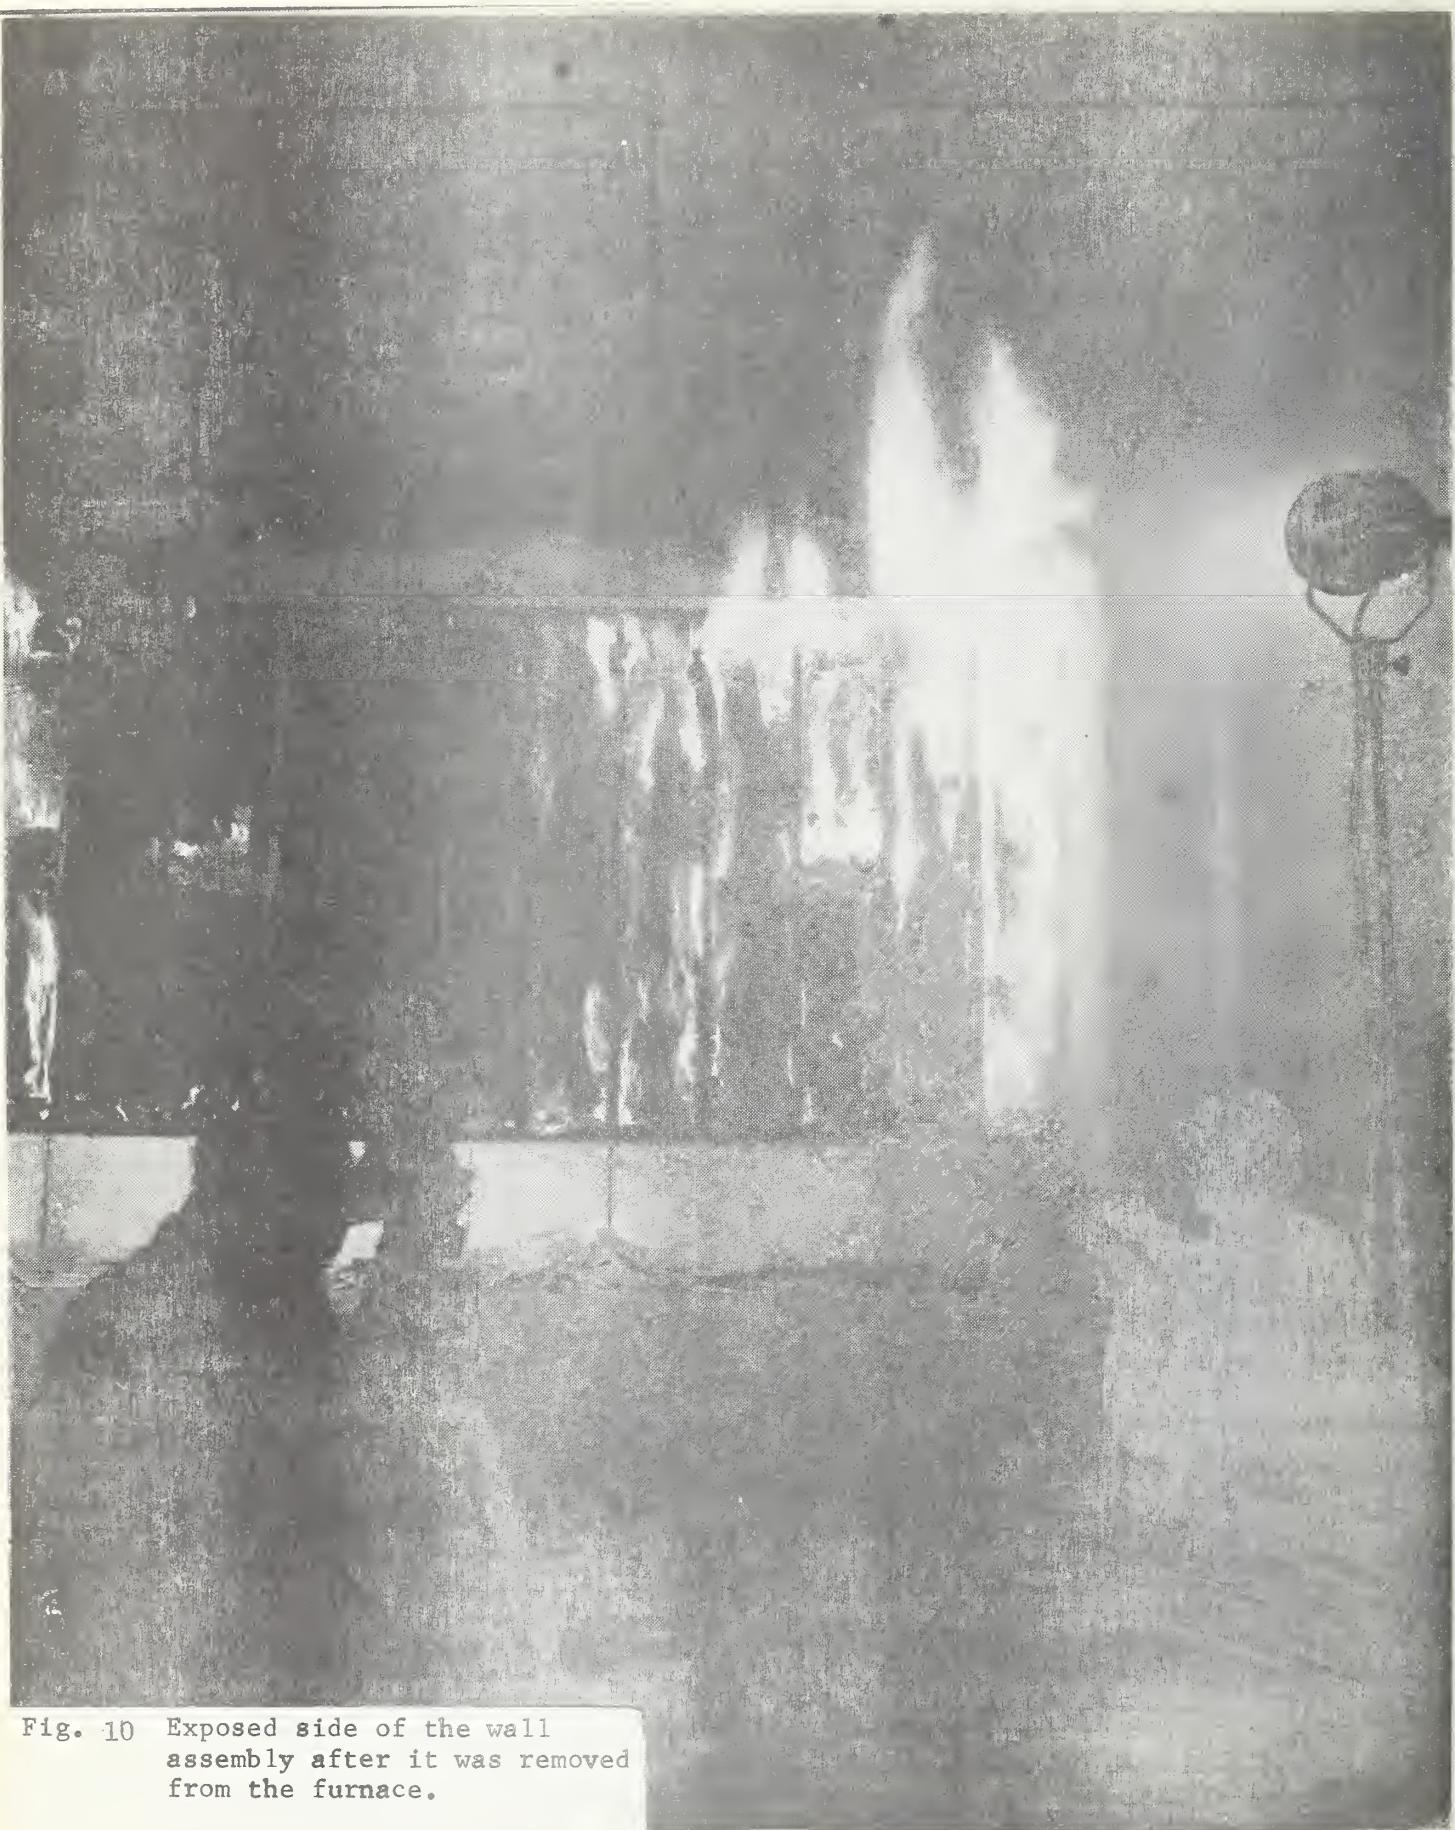
Fig. 10 Exposed side of the wall assembly after it was removed from the furnace.
